CSA GROUP
Laboratory Test Data - UL 9540A

Subject: *Li-ion Battery System, Model X1-P6K-B30-US (UL 9540A Test Report)*

Laboratory Test Data – UL 9540A Checklist and Test Result (Unit Level)

Standard(s): ANSI/CAN/UL 9540A:2019 Fourth Edition, Dated November 12, 2019 - Test Method for Evaluating Thermal Runaway Fire Propagation in Battery Energy Storage Systems

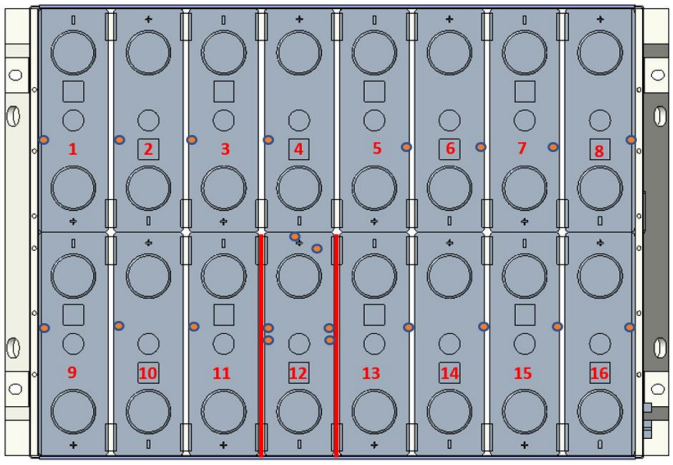
Figure 12: Initiating cell (No.12) of initiating module & thermal couplers (red dots) location

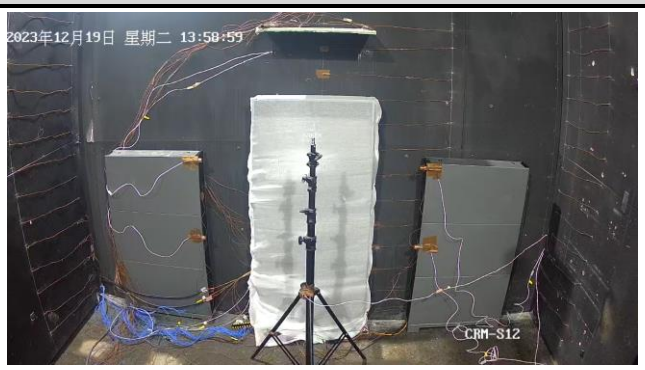
Figure 15: During cell 12 venting (Time in 13:58)

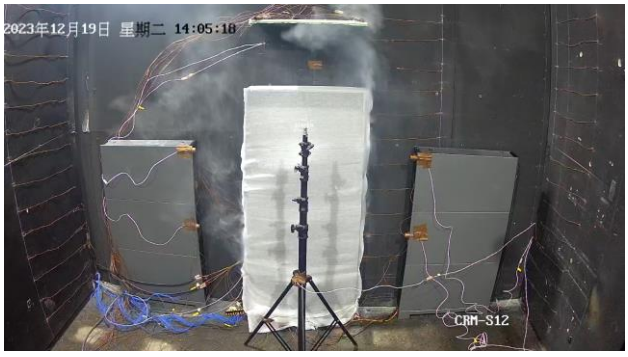
Figure 16: During cell 12 thermal runaway (Time in 14:05)

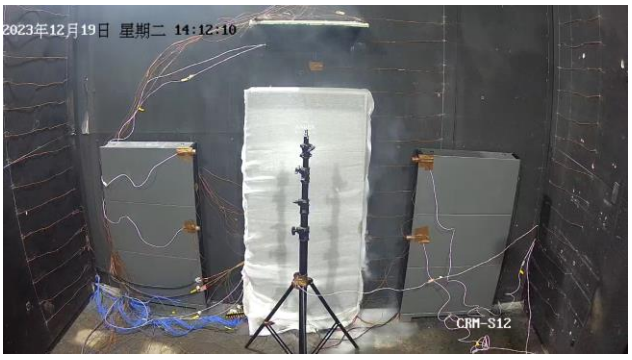
Figure 20: During cell 13 thermal runaway (Time in 14:12)

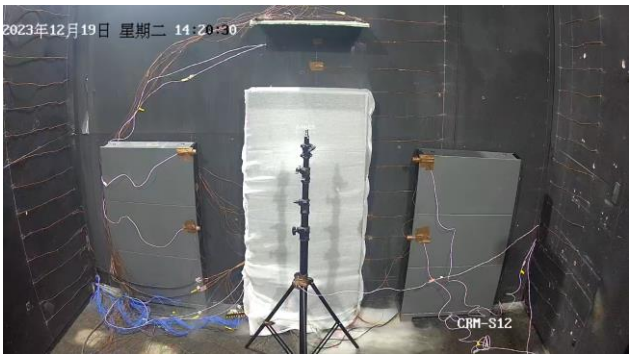
Figure 21: During cell 10 thermal runaway (Time in 14:20)

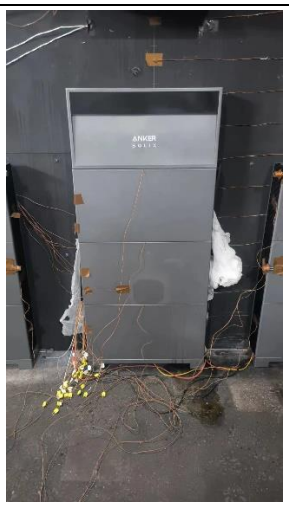
Figure 24: Initial Unit after test

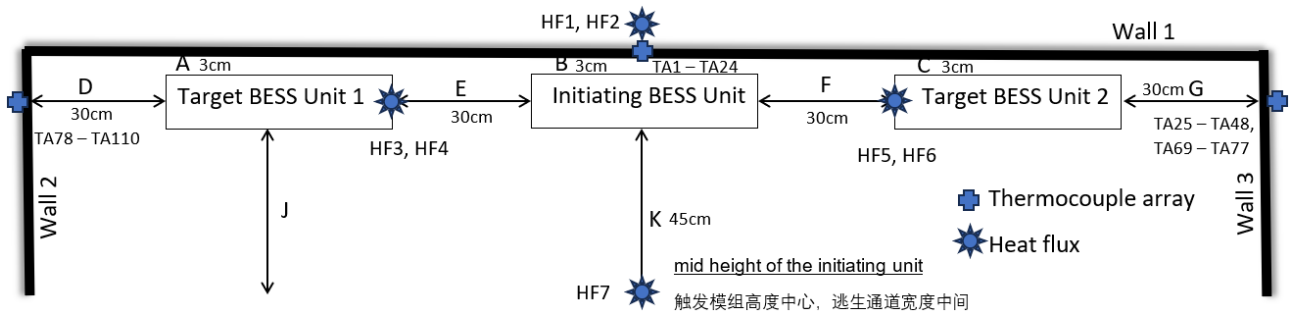
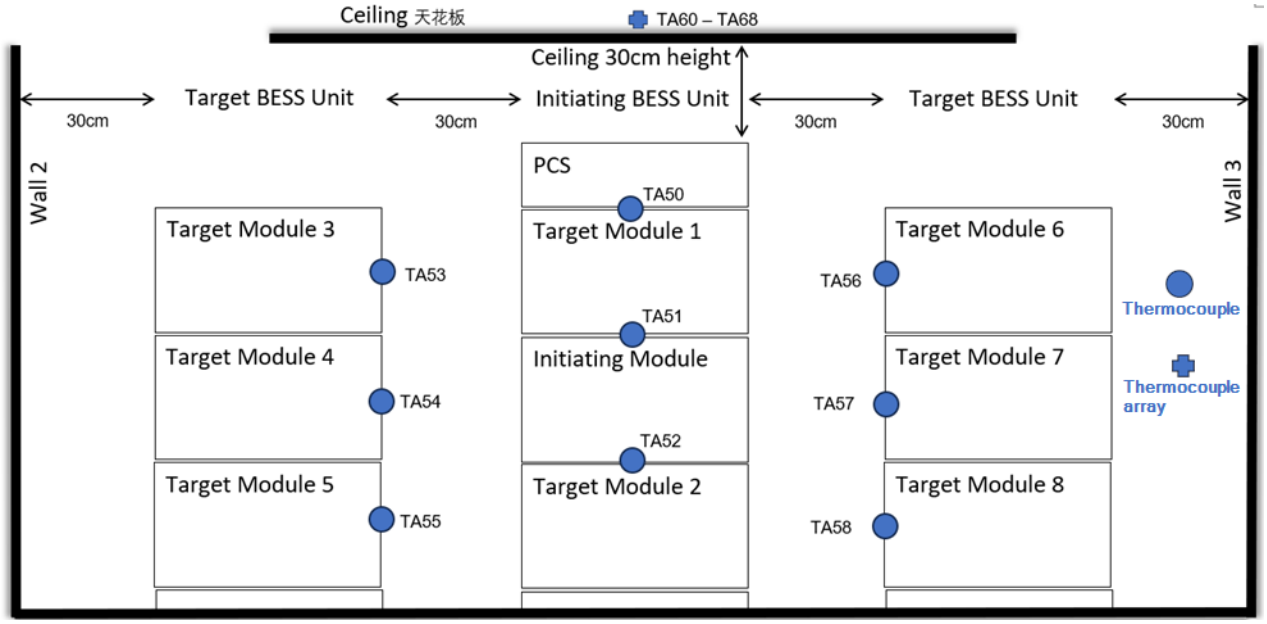
Attachment 3 - Diagram and dimension of test setup

Separation distance and other critical dimension detail		
Location	Required by manufacturer (mm)	Measured (mm)
Distance between target unit 1 and wall 1	Fixed with mount brackets (30mm)	30
Distance between initiating unit and wall 1	Fixed with mount brackets (30mm)	30
Distance between initiating unit and target unit 2	300	300
Distance between initiating unit and target unit 1	300	300
Distance between Wall 3 and target unit 2	300	300
Distance between Wall 2 and target unit 1	300	300
Clearances to accessible means of egress	900	900

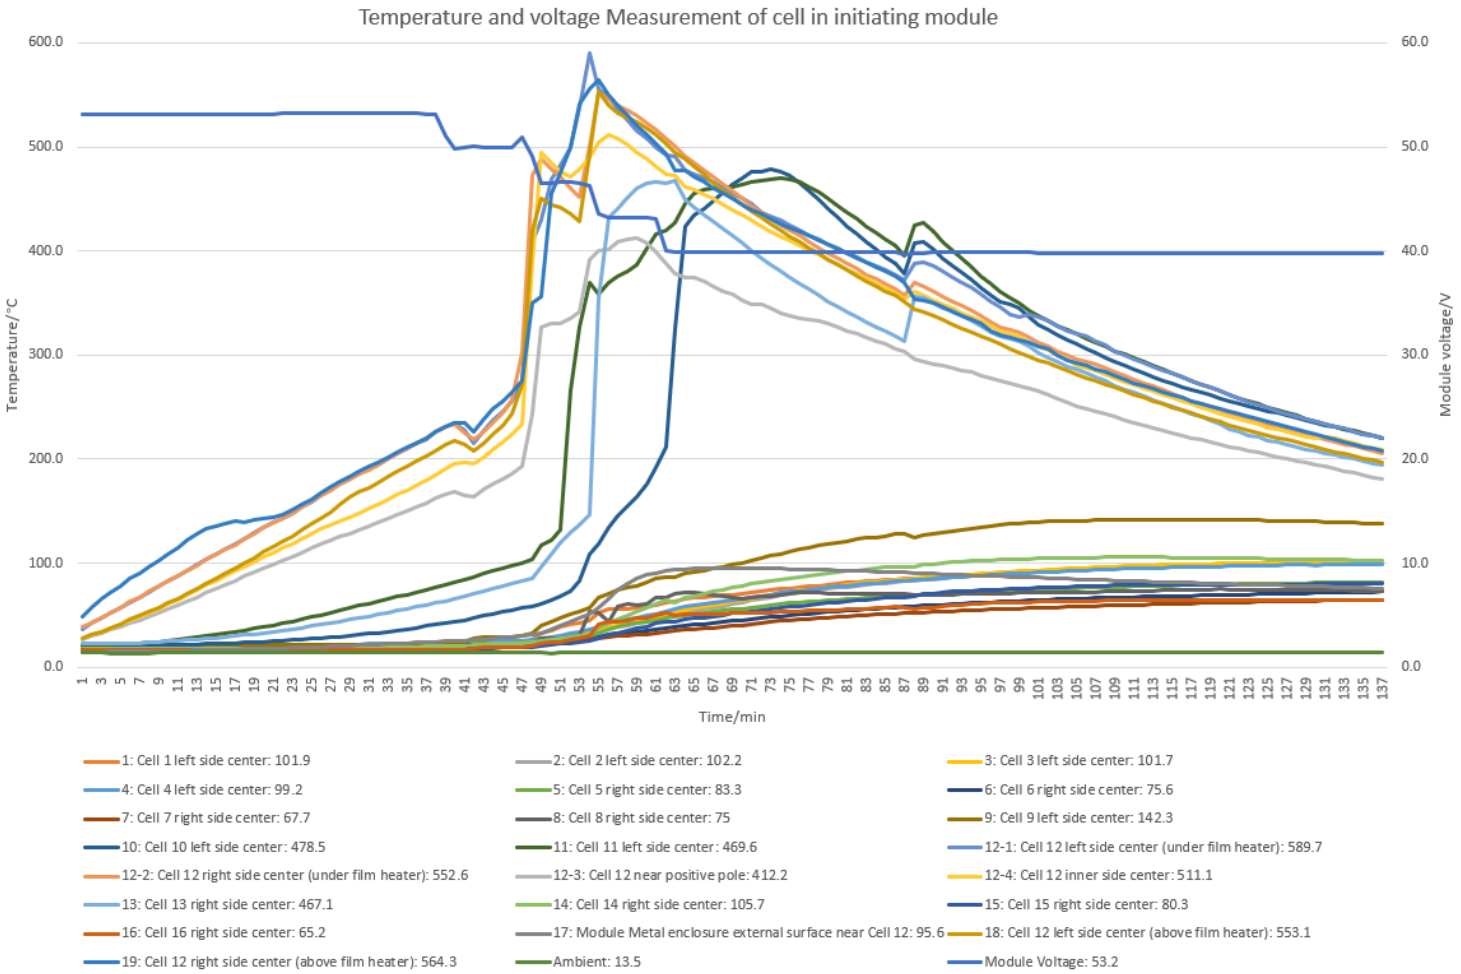
Figure 25: Temperature and voltage Measurement of cell in initiating module

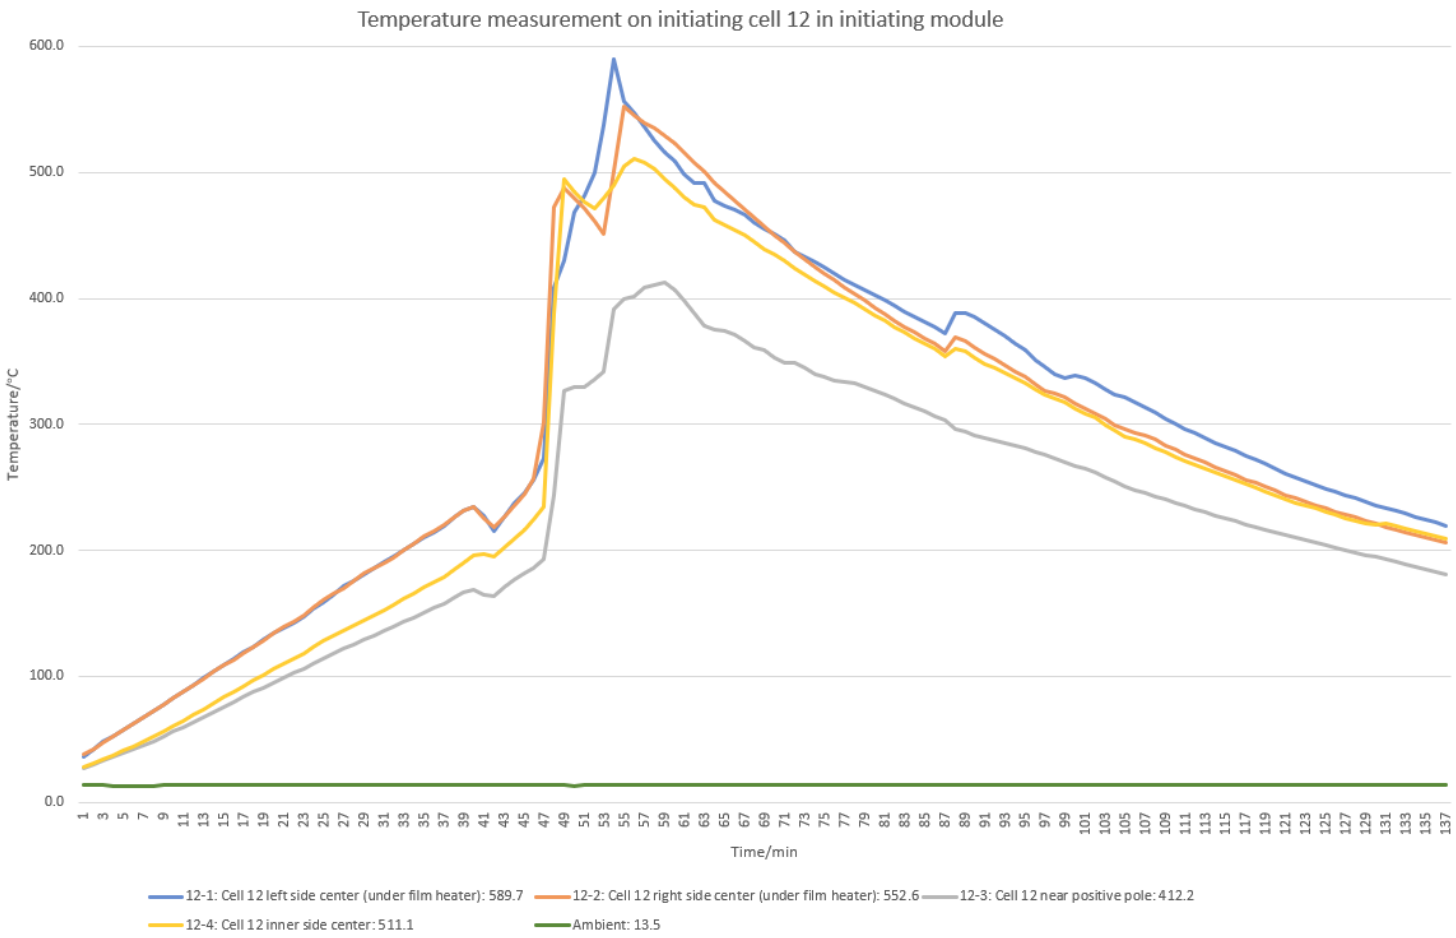
Figure 26: Temperature measurement on initiating cell 12 in initiating module

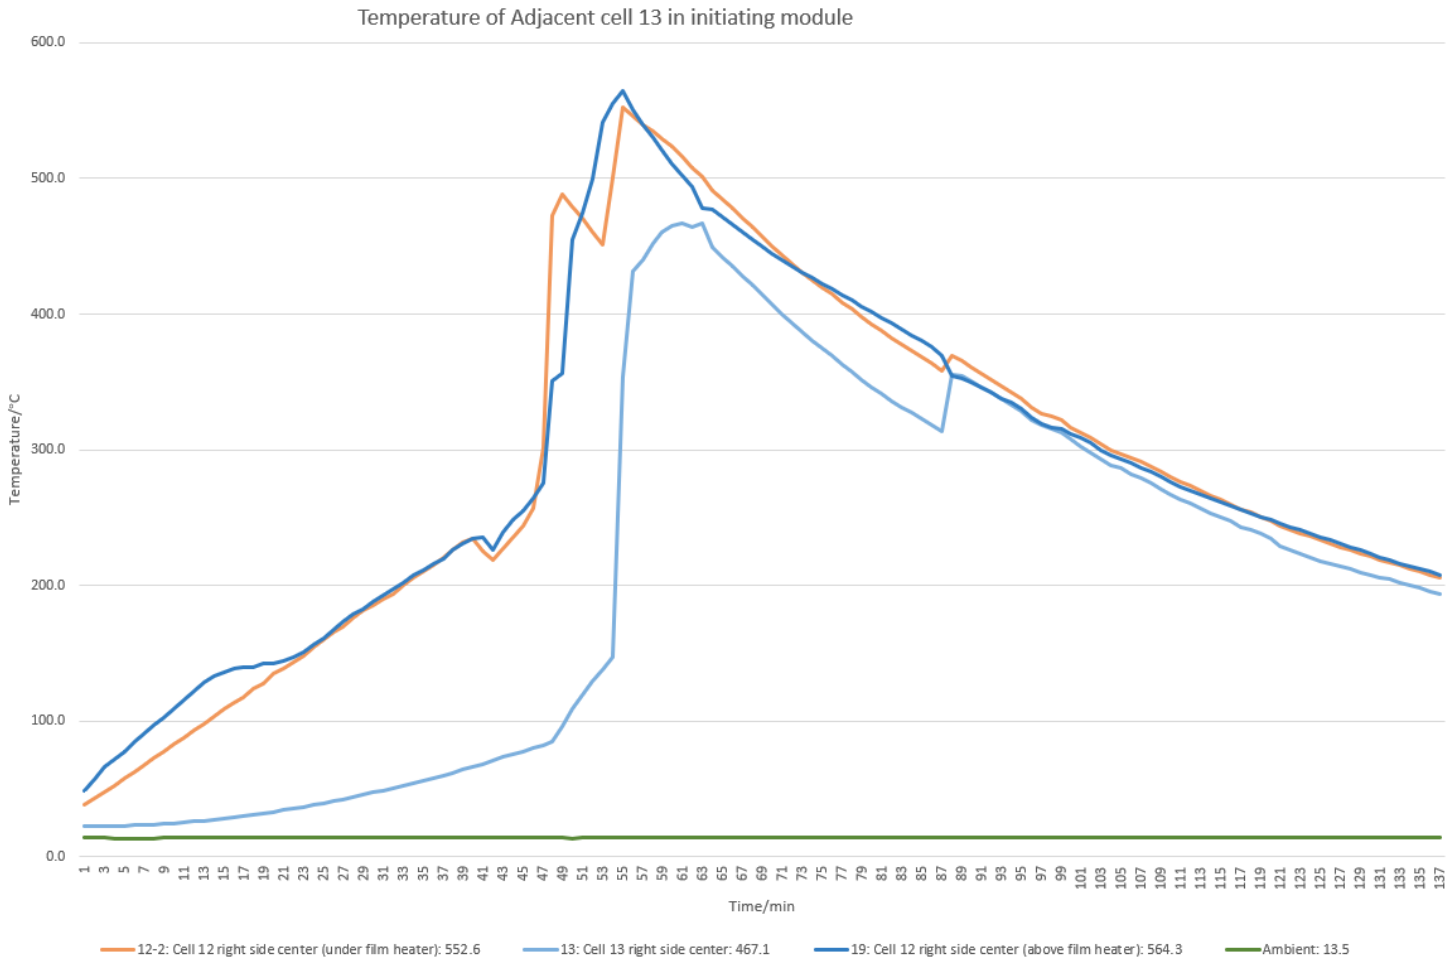
Figure 28: Temperature of Adjacent cell 13 in initiating module

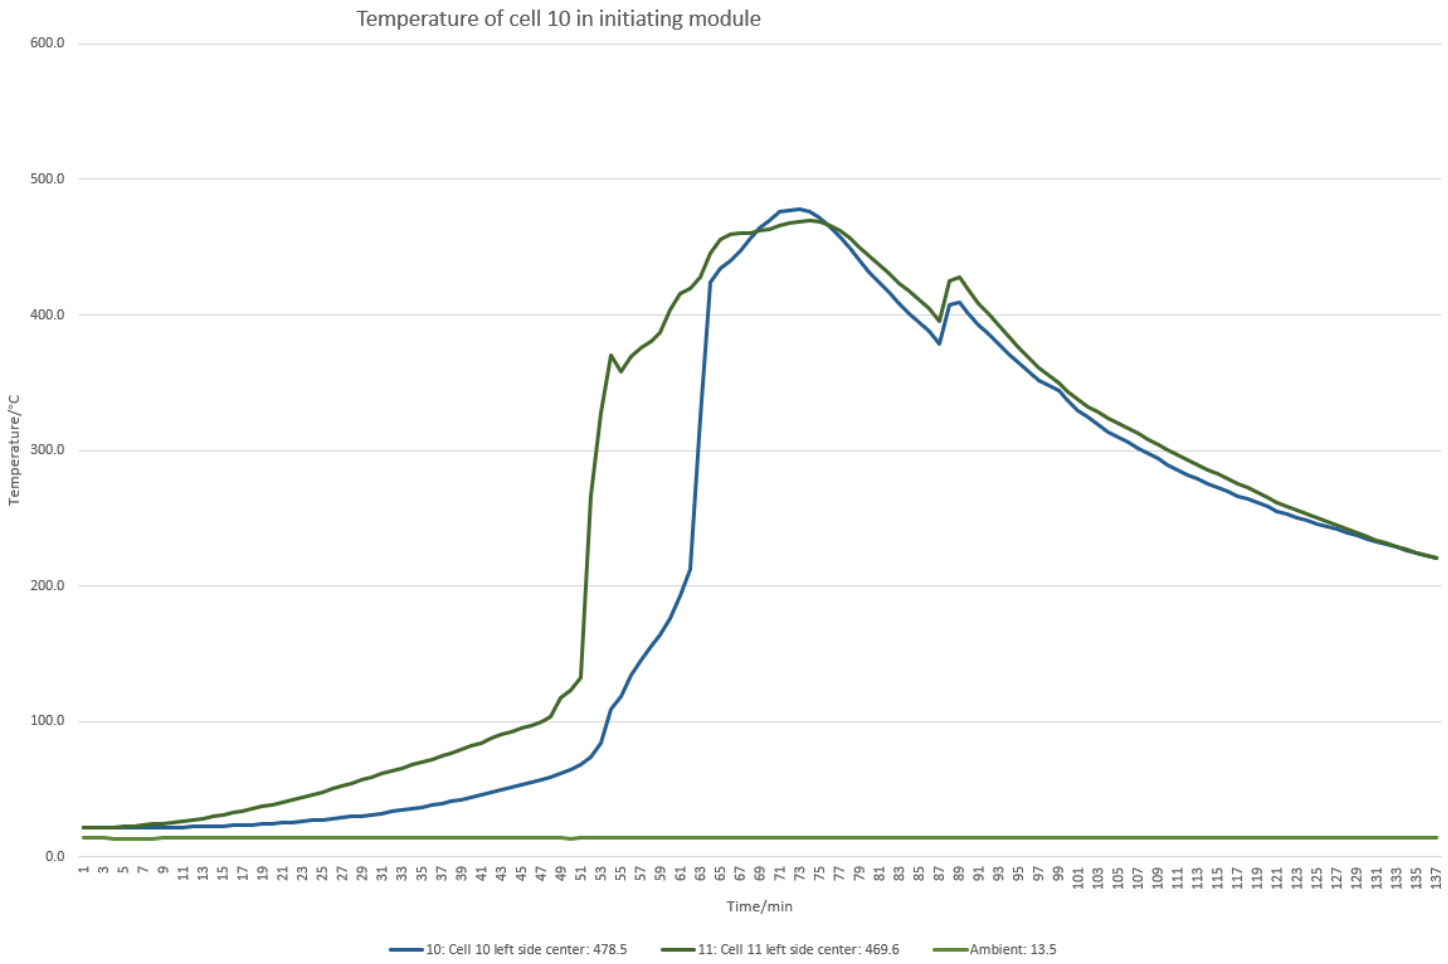
Figure 29: Temperature of cell 10 in initiating module

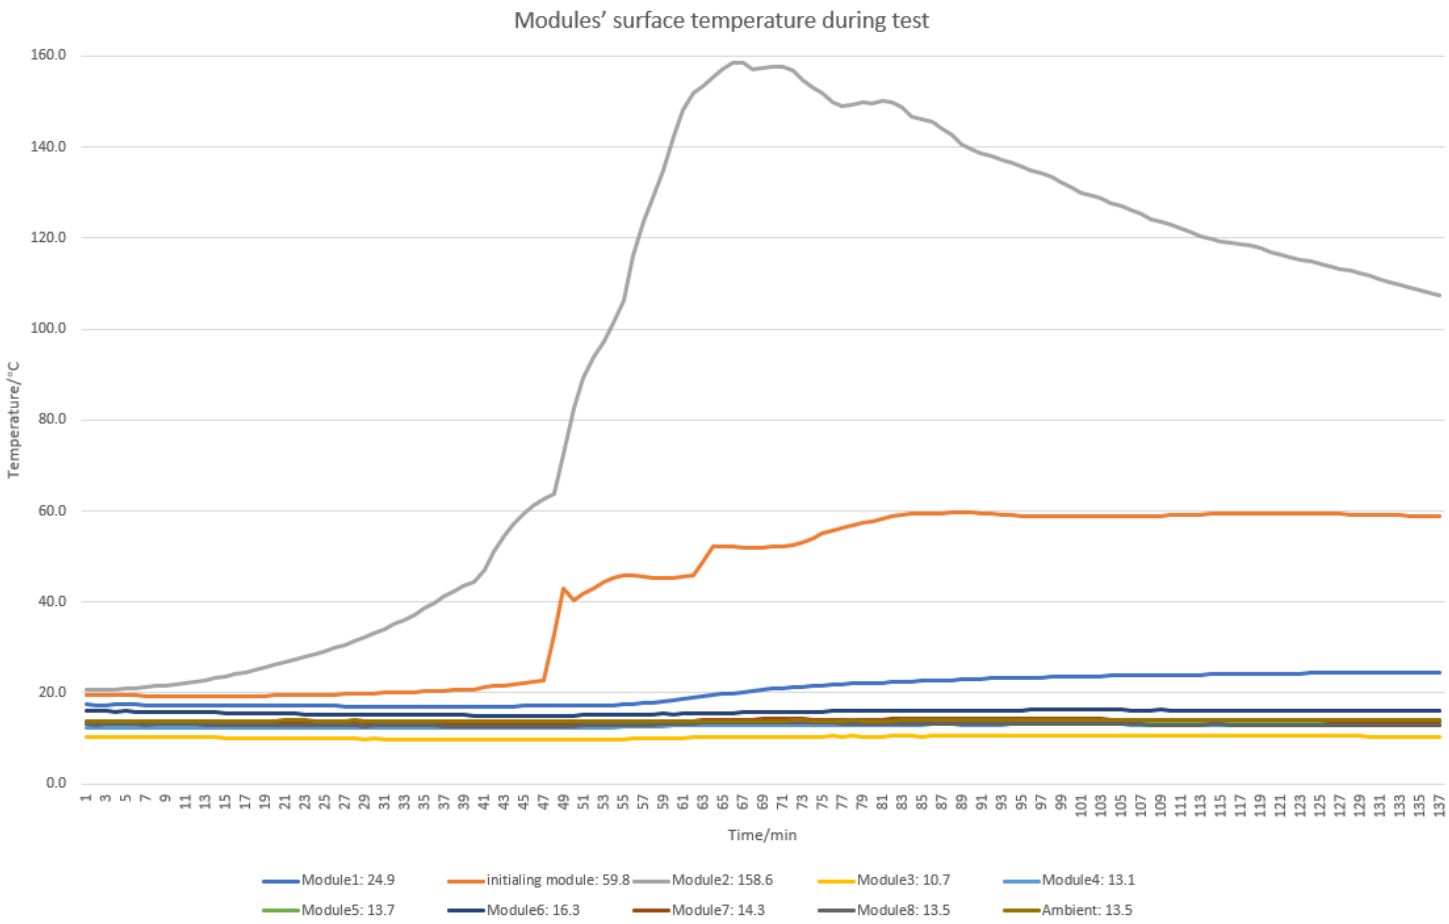
Figure 30: Modules' surface temperature during test (Refer to Attachment 3 - Diagram and dimension of test setup for the thermal coupler locations)

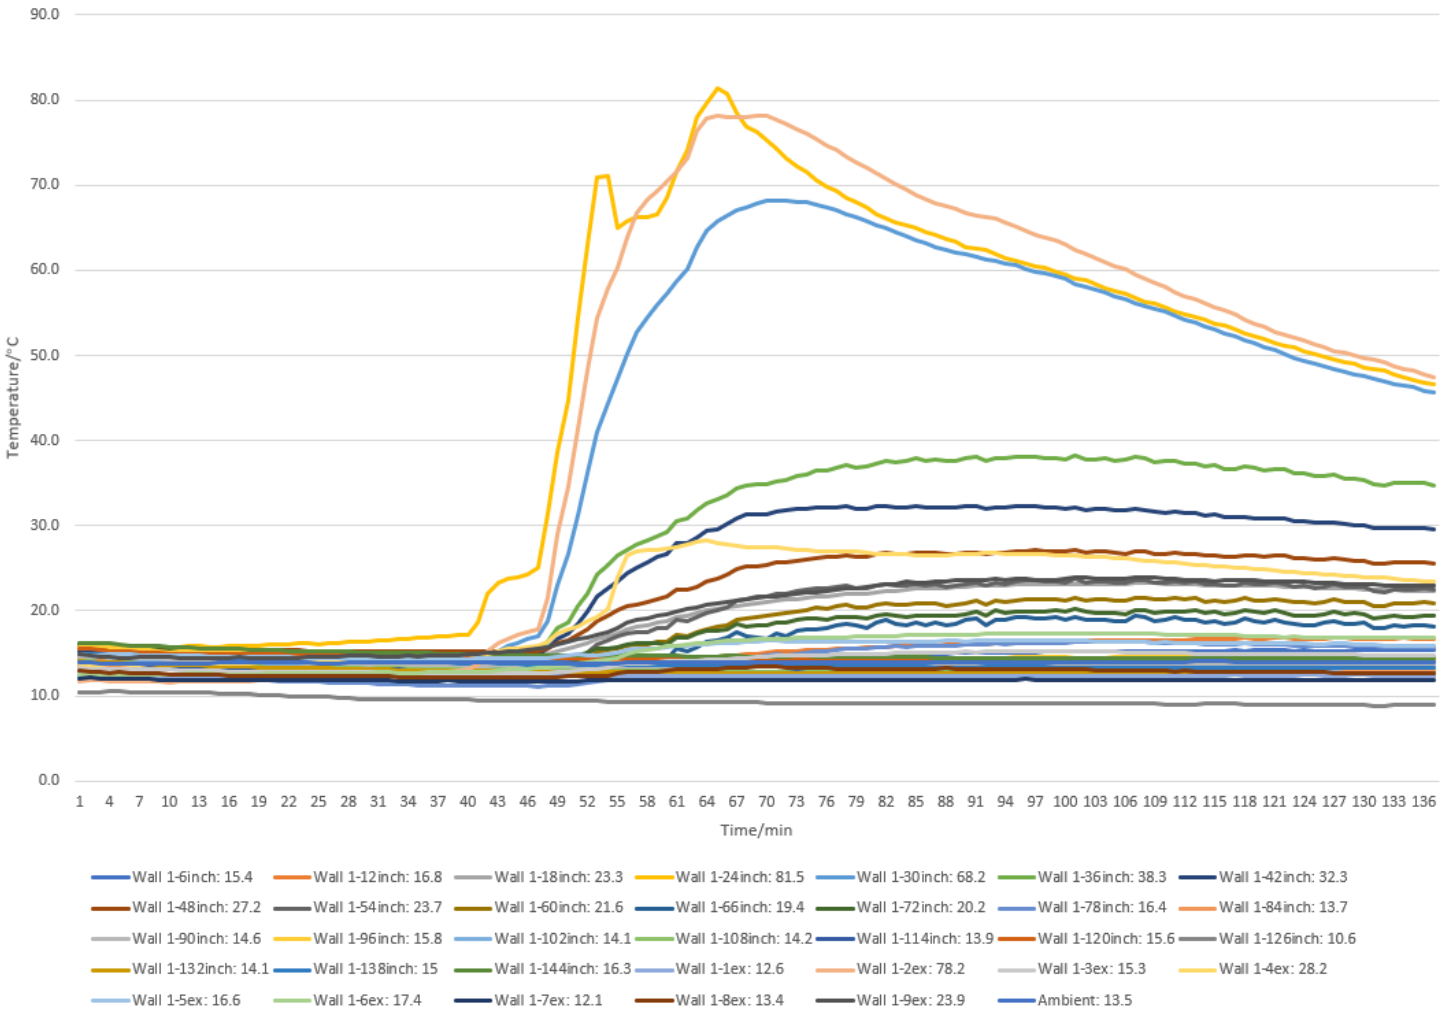
Figure 31: Wall 1's temperature during test (Refer to Attachment 3 - Diagram and dimension of test setup for the thermal coupler locations)

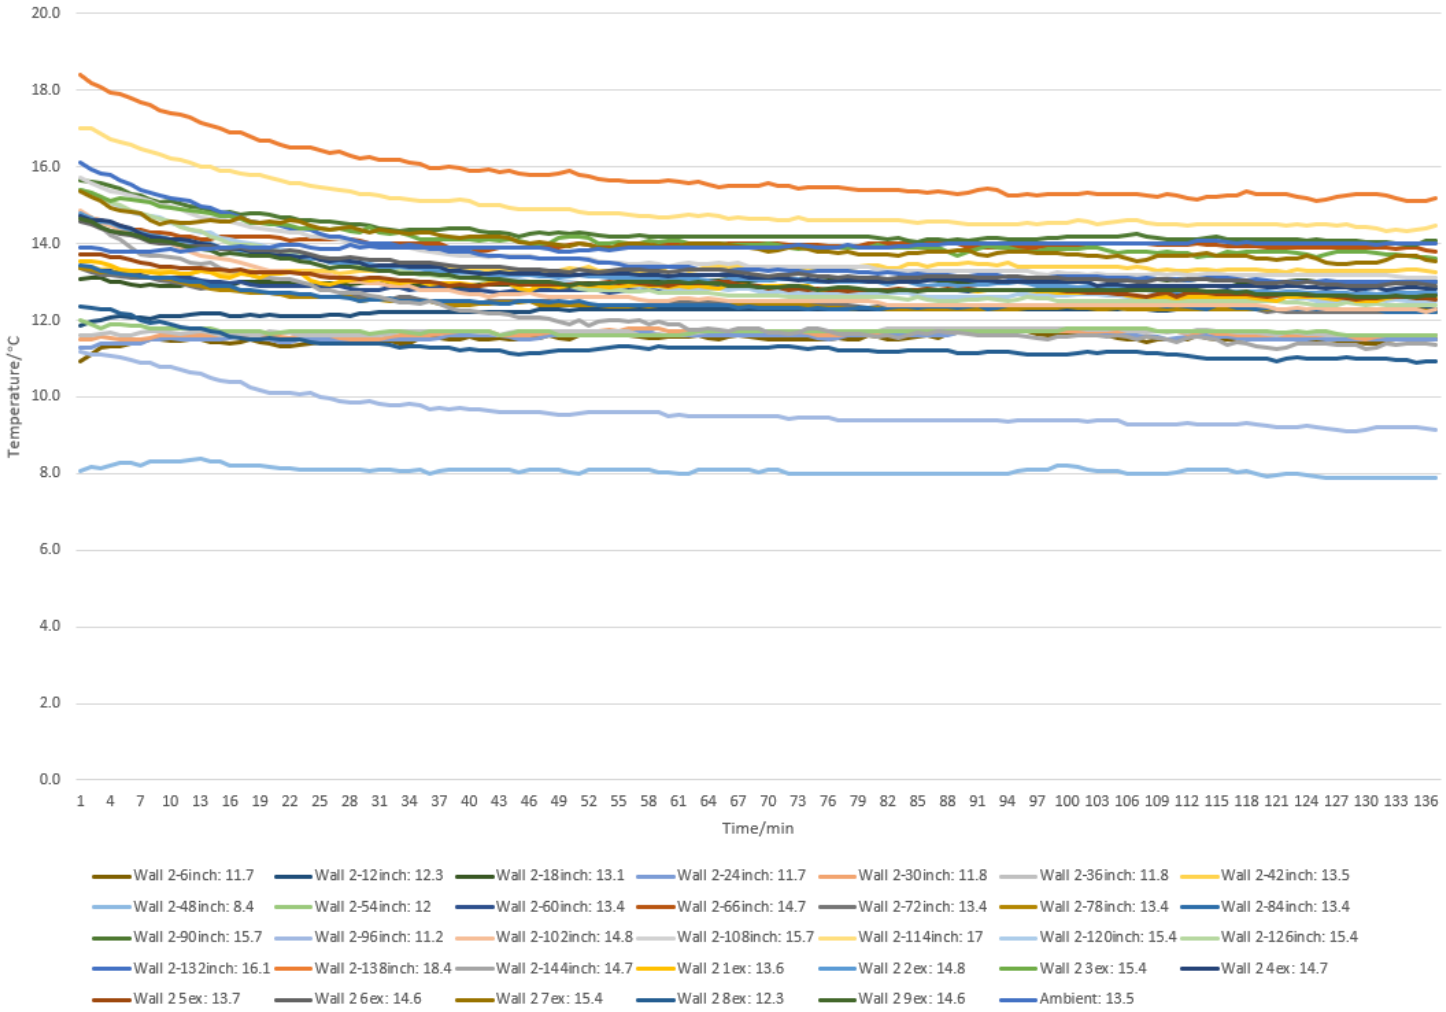
Figure 32: Wall 2's temperature during test (Refer to Attachment 3 - Diagram and dimension of test setup for the thermal coupler locations)

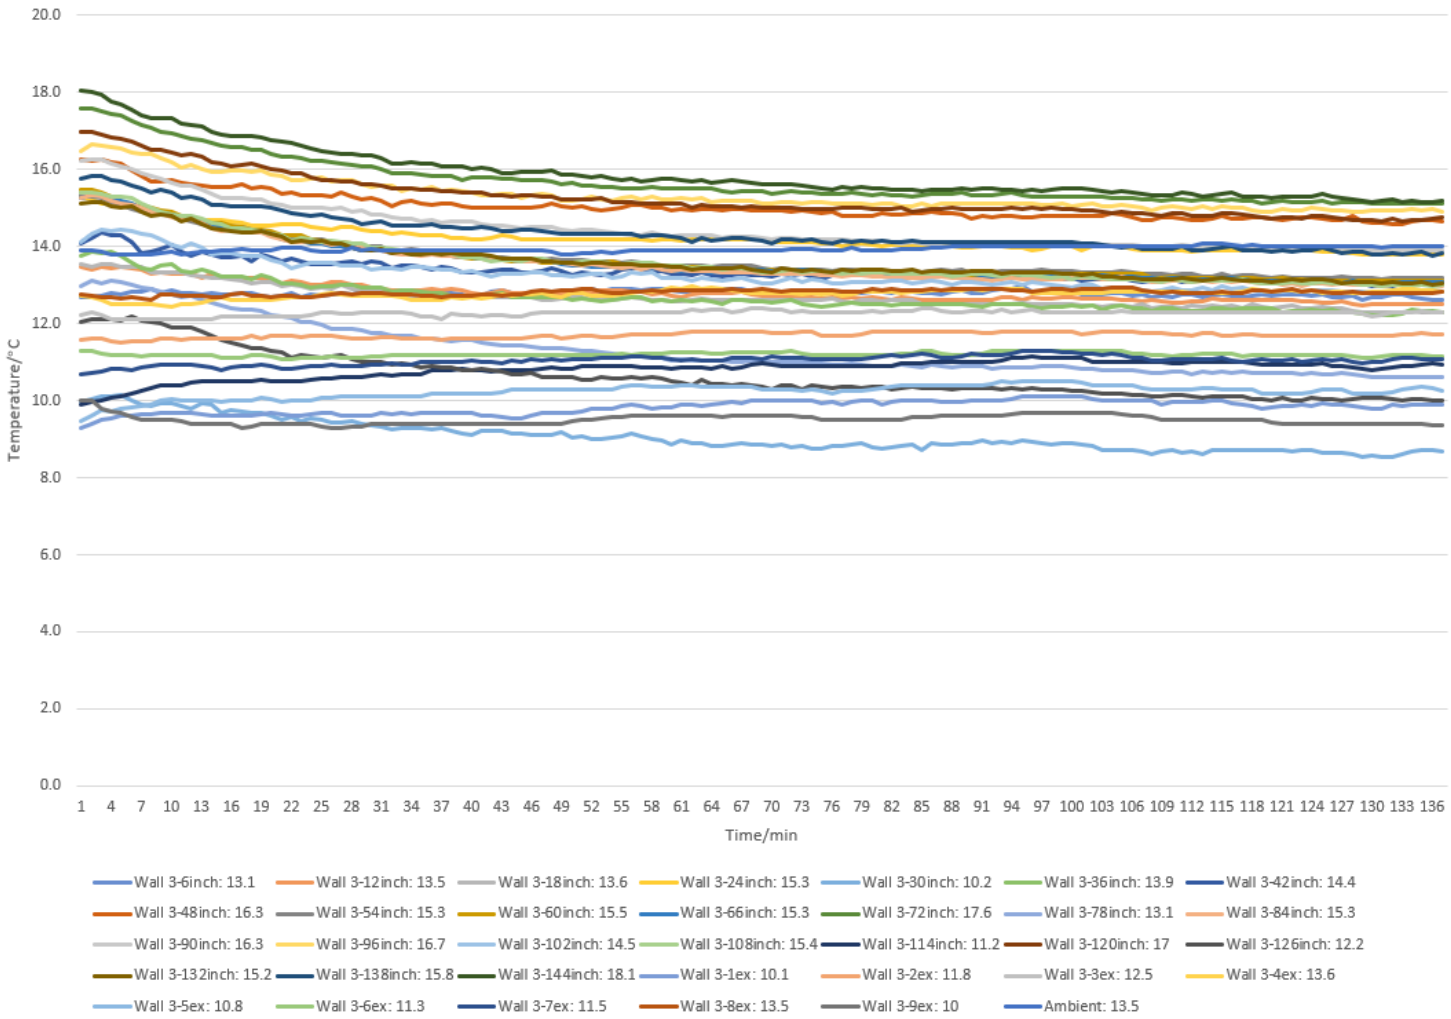
Figure 33: Wall 3's temperature during test (Refer to Attachment 3 - Diagram and dimension of test setup for the thermal coupler locations)

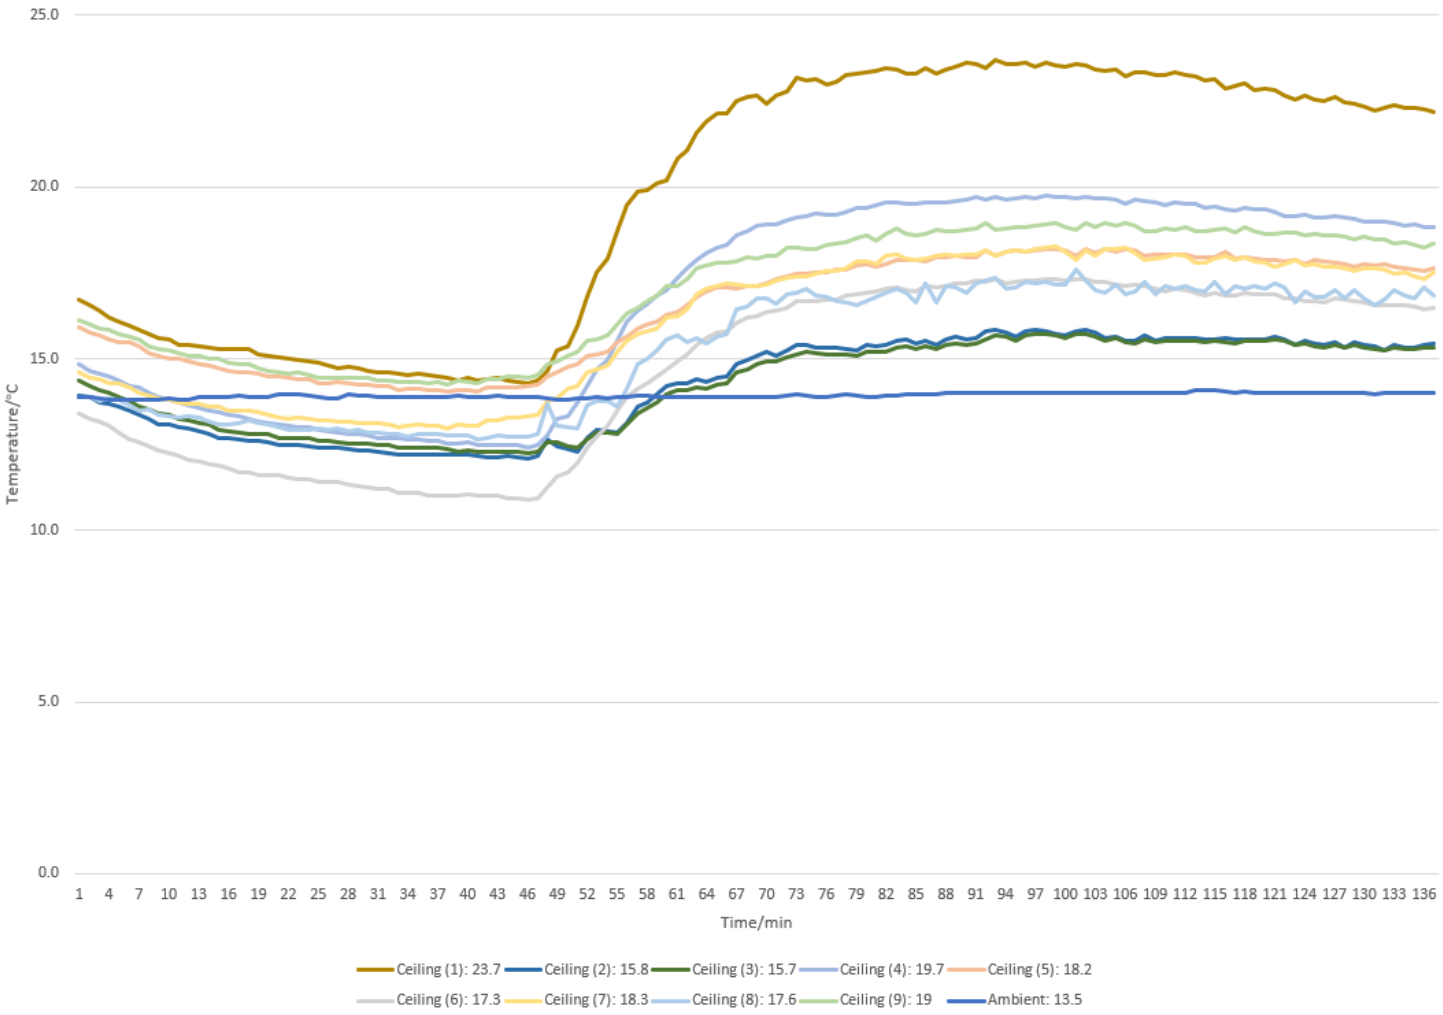
Figure 34: Ceiling/soffit's temperature during test (Refer to Attachment 3 - Diagram and dimension of test setup for the thermal coupler locations)

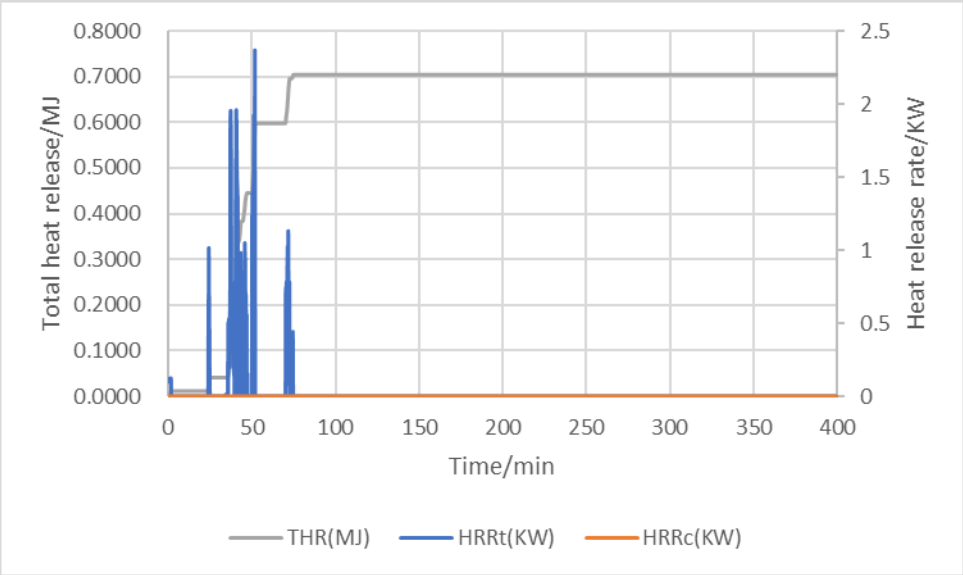
Attachment 5 - Heat release rate graphs

i) Observation of any flaming outside the initiating BESS enclosure and the maximum flame extension;	Not observed	P
	j) Chemical and convective heat release rate versus time data;	See attachment 5 for details	P

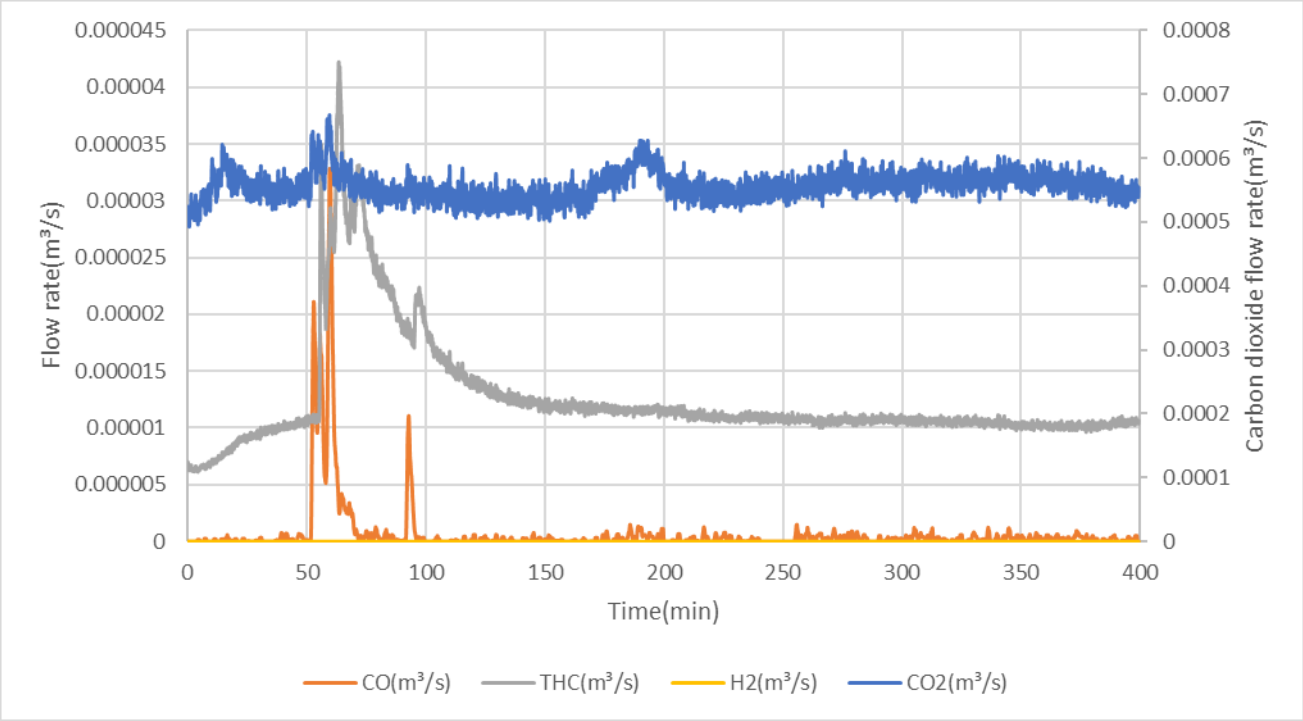
Attachment 6 - Gas generation graphs

Table 3 – Unit level test	
Sample Number:	202312025
Ambient temperature at start of test, (°C)	14
Ambient temperature range during test, (°C)	13.5 to 14.1
Relative humidity, (%RH)	66
Number of cells used for initiating thermal runaway:	1
Open circuit voltage before test, (Vdc)	53.1
External film heater ramp rate, (°C/min)	5.1
Other method used to initiate thermal runaway:	N/A
Location of cell and module for initiating thermal runaway:	See attachment 2 for details
Number of cells exhibited thermal runaway within initiating module:	4
Number of modules exhibited thermal runaway within initiating BESS:	1
Location of cell and module exhibited thermal runaway within initiating BESS:	See attachment 2 for details
Cell to cell propagation condition:	Yes
Peak chemical heat release rate, (kW)	2.358
Peak convective heat release rate, (kW)	0
Flammable gas generation, (Liter)	Before Flaming: 147.96 After Flaming: No flaming

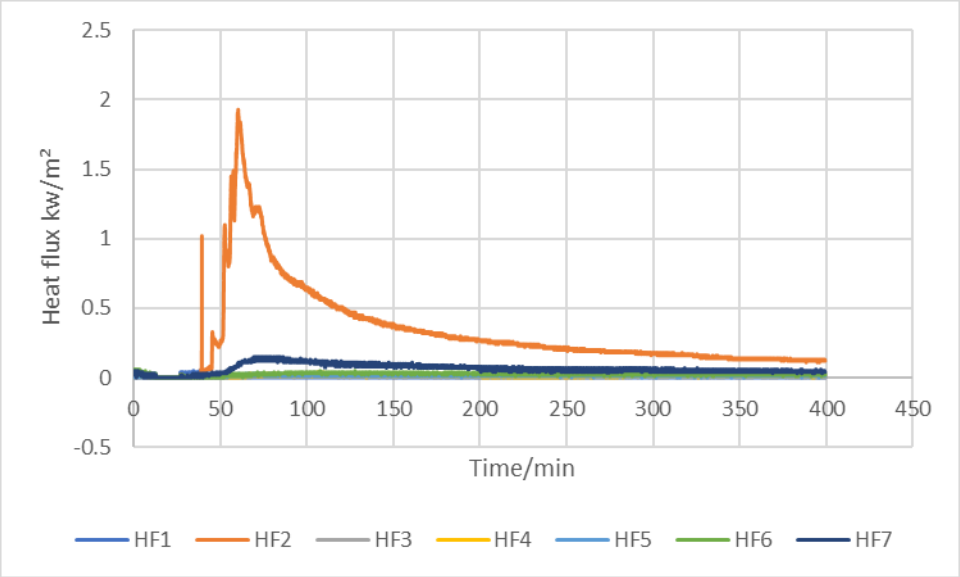
Table 6 – Maximum Heatflux measurement

Location	Heatflux limit (kW/m^2)	Measured maximum Heatflux (kW/m^2)
Heat flux 7 at initiating unit middle height and center of egress	1.3	0.15
Heat flux 3 at target unit 1 and the height of the unit	-	0.02
Heat flux 4 at target unit 1 and the height of initiating module	-	0.04
Heat flux 2 at wall 1 and the height of initiating module	-	1.93
Heat flux 1 at wall 1 and the height of top module	-	0.05
Heat flux 5 at target unit 2 and the height of the unit	-	0.15
Heat flux 6 at target unit 2 and the height of initiating module	-	0.06
Note: As the cheesecloth may partially occlude heat flux transmission, the value of heat flux only for reference.
